Proceeding of NPUA. "Chemical and environmental technologies". 2016, № 2

TMF WATERPROOFING COURSE FILTRATION TEST

T.S. Navasardyan

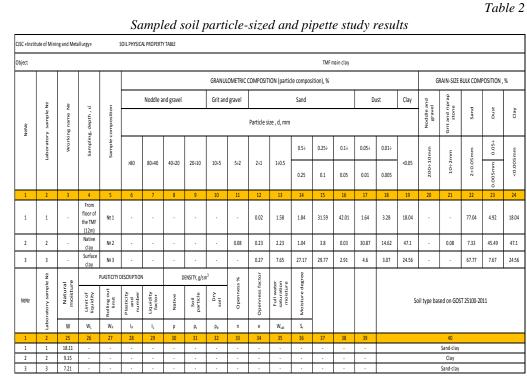
As a result of the particle-size study, the number of particles of up to 0.5 *mm* in diameter was found (according to classifications), and as a result of the pipette study, the percentage and weight of particles of less than 0.5 in diameter in the sample were found (table 2).

The obtained results were compared to the GOST 25100-2011 soil standards, and the class of the sample soil was found.

After the detailed study of the results, it becomes clear that the clay mass used as a waterproofing course, after a long stay under the TMF mass, underwent a physical

As for the 3rd soil sample in table 2, we can say that it also lost its waterproofing property and it is not efficient to be used as a surface waterproofing course.

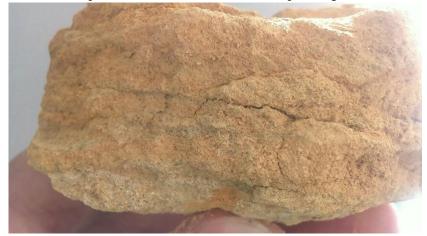
The plausible reason can be a geochemical migration, as a result of which minerals in the TMF mass penetrate through migration into the waterproofing clay

layer and have an impact on the particle-size and chemical structure of the waterproofing course (fig.). It is also shown in the laboratory test results. As a result of the physical structure change, the soil type is also changed, from clay into sand-clay, which means it is not possible to use that soil as a waterproofing course.

Fig. Waterprofing layer change as a result of geochemical migration
